CORNER RECORD

Document Number 1857

Brief Legal Description Southwest Corner of Section 14, T.7S, R.14E.

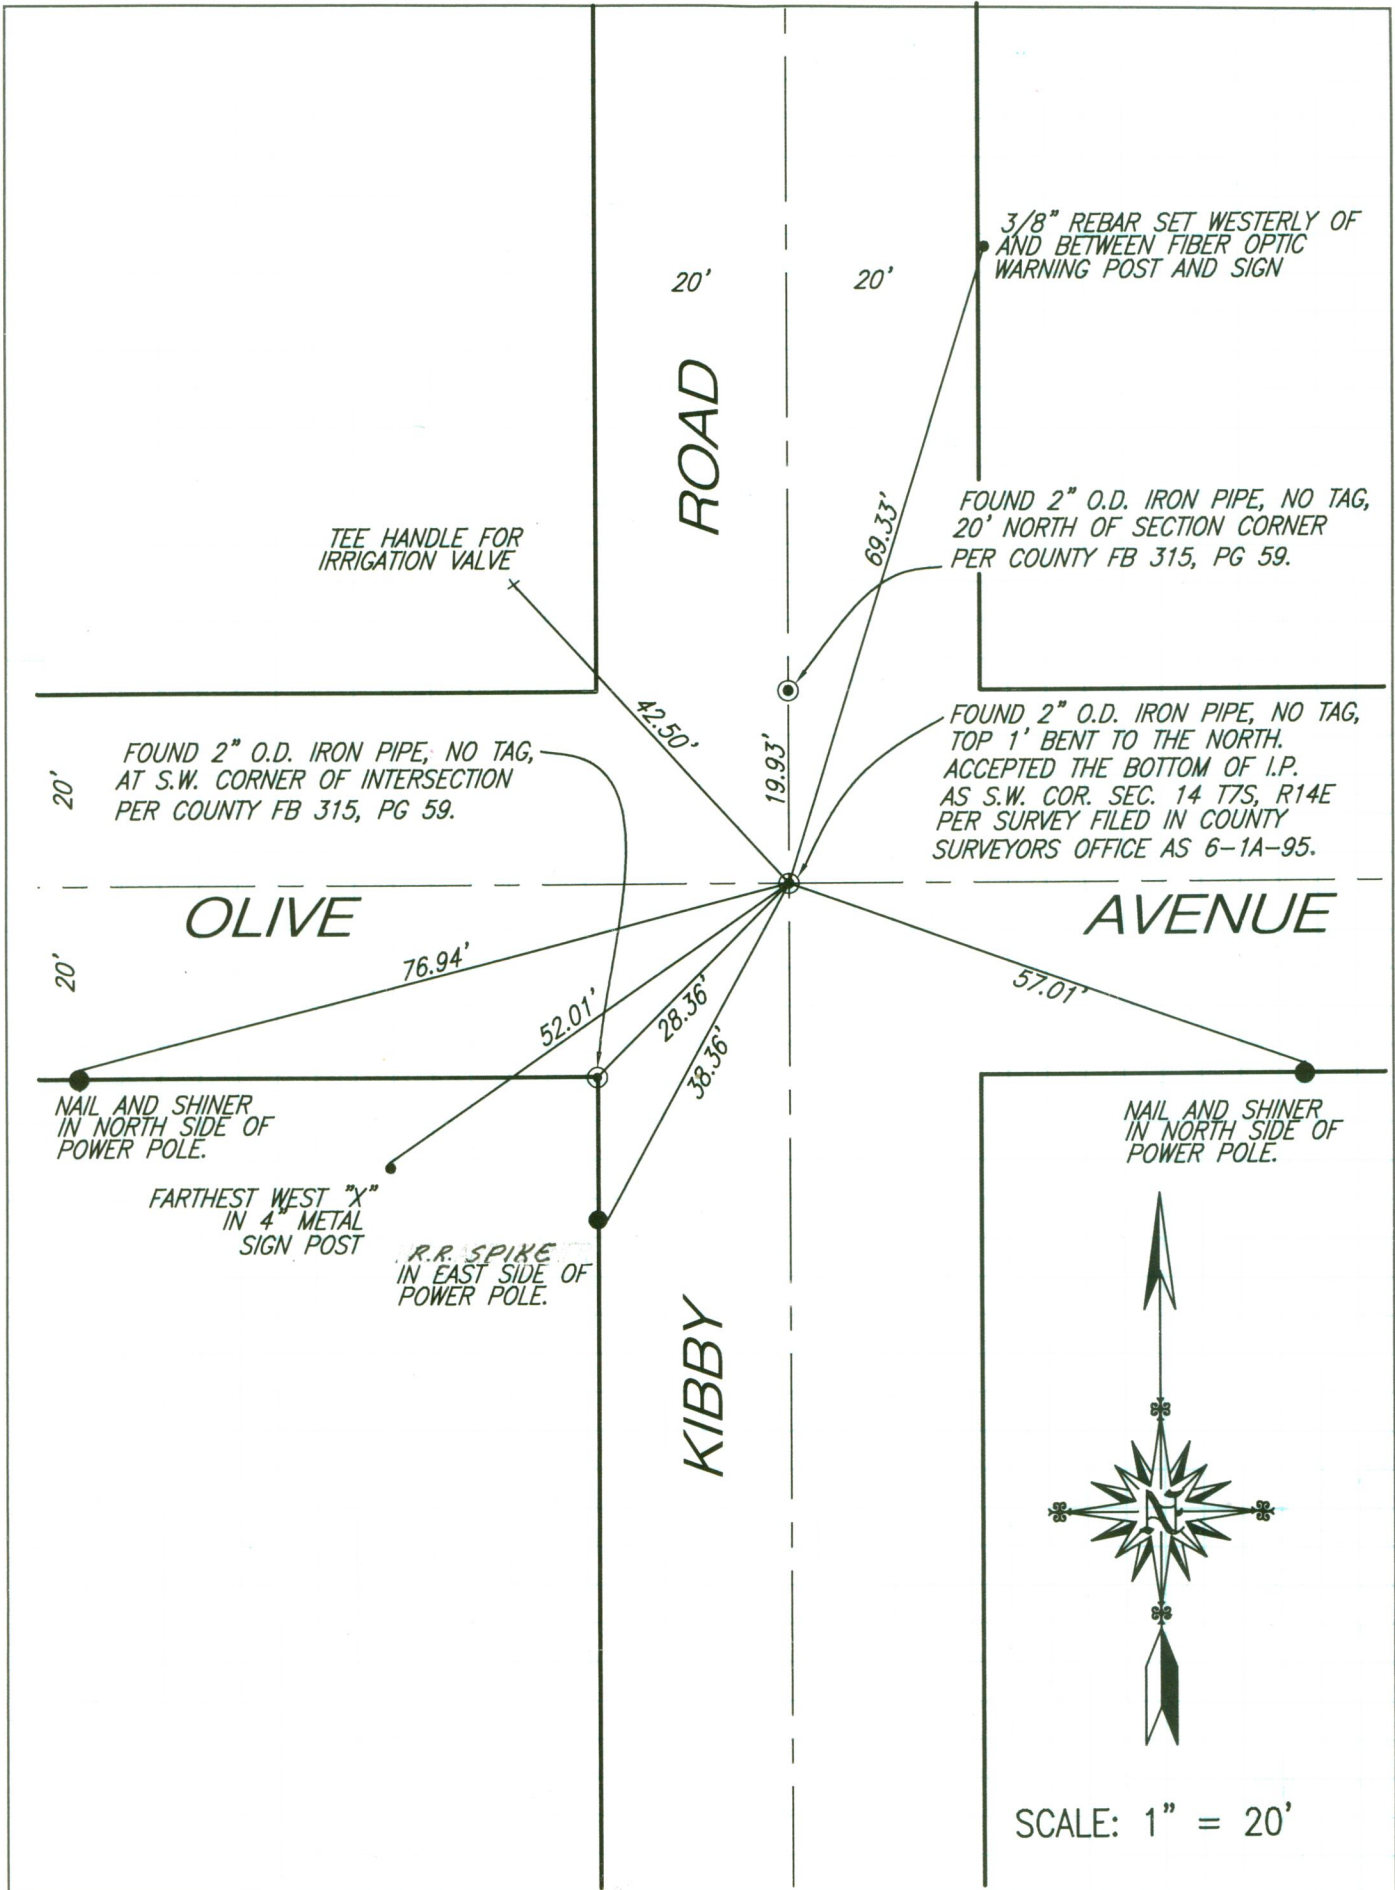
3/8" REBAR SET WESTERLY OF AND BETWEEN FIBER OPTIC WARNING POST AND SIGN

FOUND 2" O.D. IRON PIPE, NO TAG, 20' NORTH OF SECTION CORNER PER COUNTY FB 315, PG 59.

FOUND 2" O.D. IRON PIPE, NO TAG, TOP 1' BENT TO THE NORTH. ACCEPTED THE BOTTOM OF I.P. AS S.W. COR. SEC. 14 T7S, R14E PER SURVEY FILED IN COUNTY SURVEYORS OFFICE AS 6-1A-95.

FOUND 2" O.D. IRON PIPE, NO TAG, AT S.W. CORNER OF INTERSECTION PER COUNTY FB 315, PG 59.

NAIL AND SHINER IN NORTH SIDE OF POWER POLE.

FARTHEST WEST "X" IN 4" METAL SIGN POST

R.R. SPIKE IN EAST SIDE OF POWER POLE.
