CORNER RECORD

NTY OF MERCED T. 9 S R. 13 E M.D.B & M. MERIDIAN CALIFORNIA
CORNER TYPE: GOV'T. CORNER MEANDER RANCHO CONTROL OTHER
CORNER IDENTIFICATION — DATE OF VISIT SEPT. 1976

SECTION CORNER: NORTH WEST CORNER SECTION 35

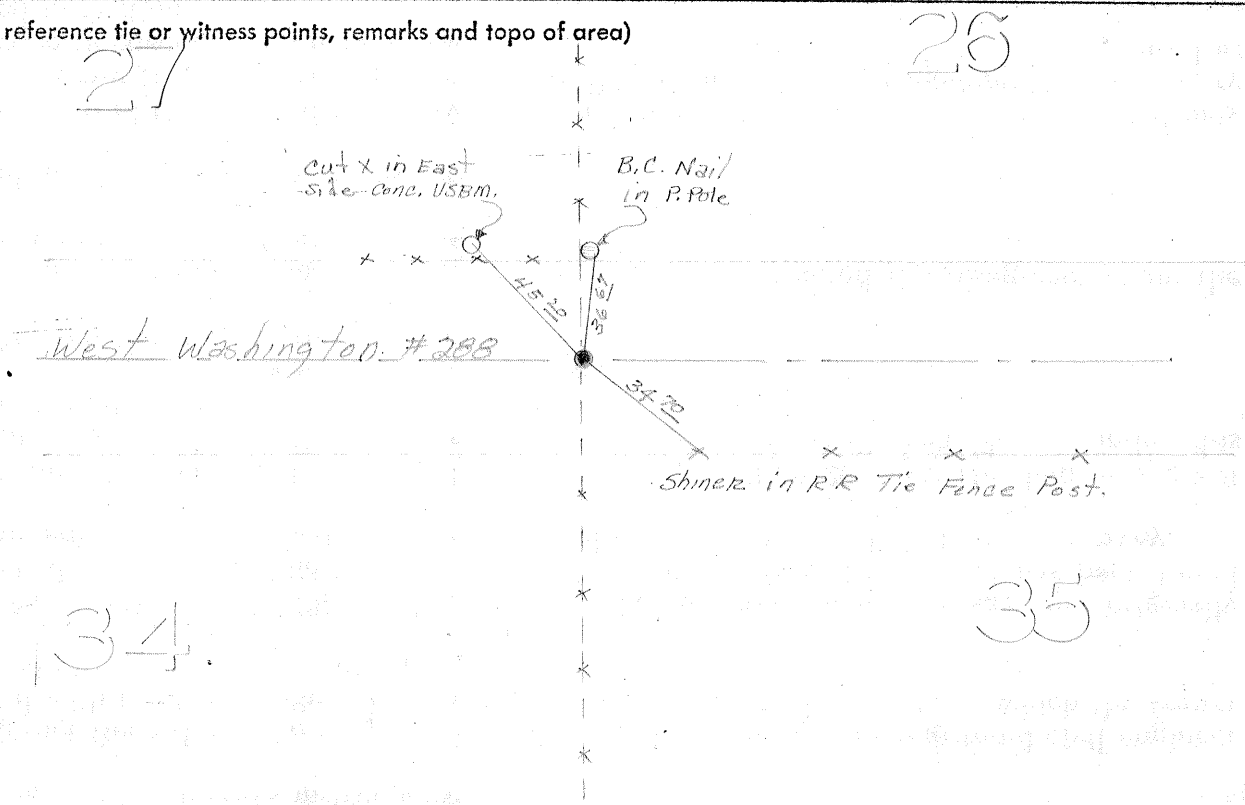
SKETCH: (Include reference tie or witness points, remarks and topo of area)

1/2" IRON PIPE WAS DESTROYED WHEN ROAD WAS REBUILT,
DUG DOWN 3'
USED SWING TIES IN BOOK 60 PG 34 M.C.R.D. TO RESET

Brought up with 2" Iron Pipe with tag 13,760 set in Survey Encasement.
