**CORNER RECORD**

Document Number 2006-Y

County of Merced, California

Brief Legal Description N.E. Corner of Santa Fe Drive & California Street intersection.

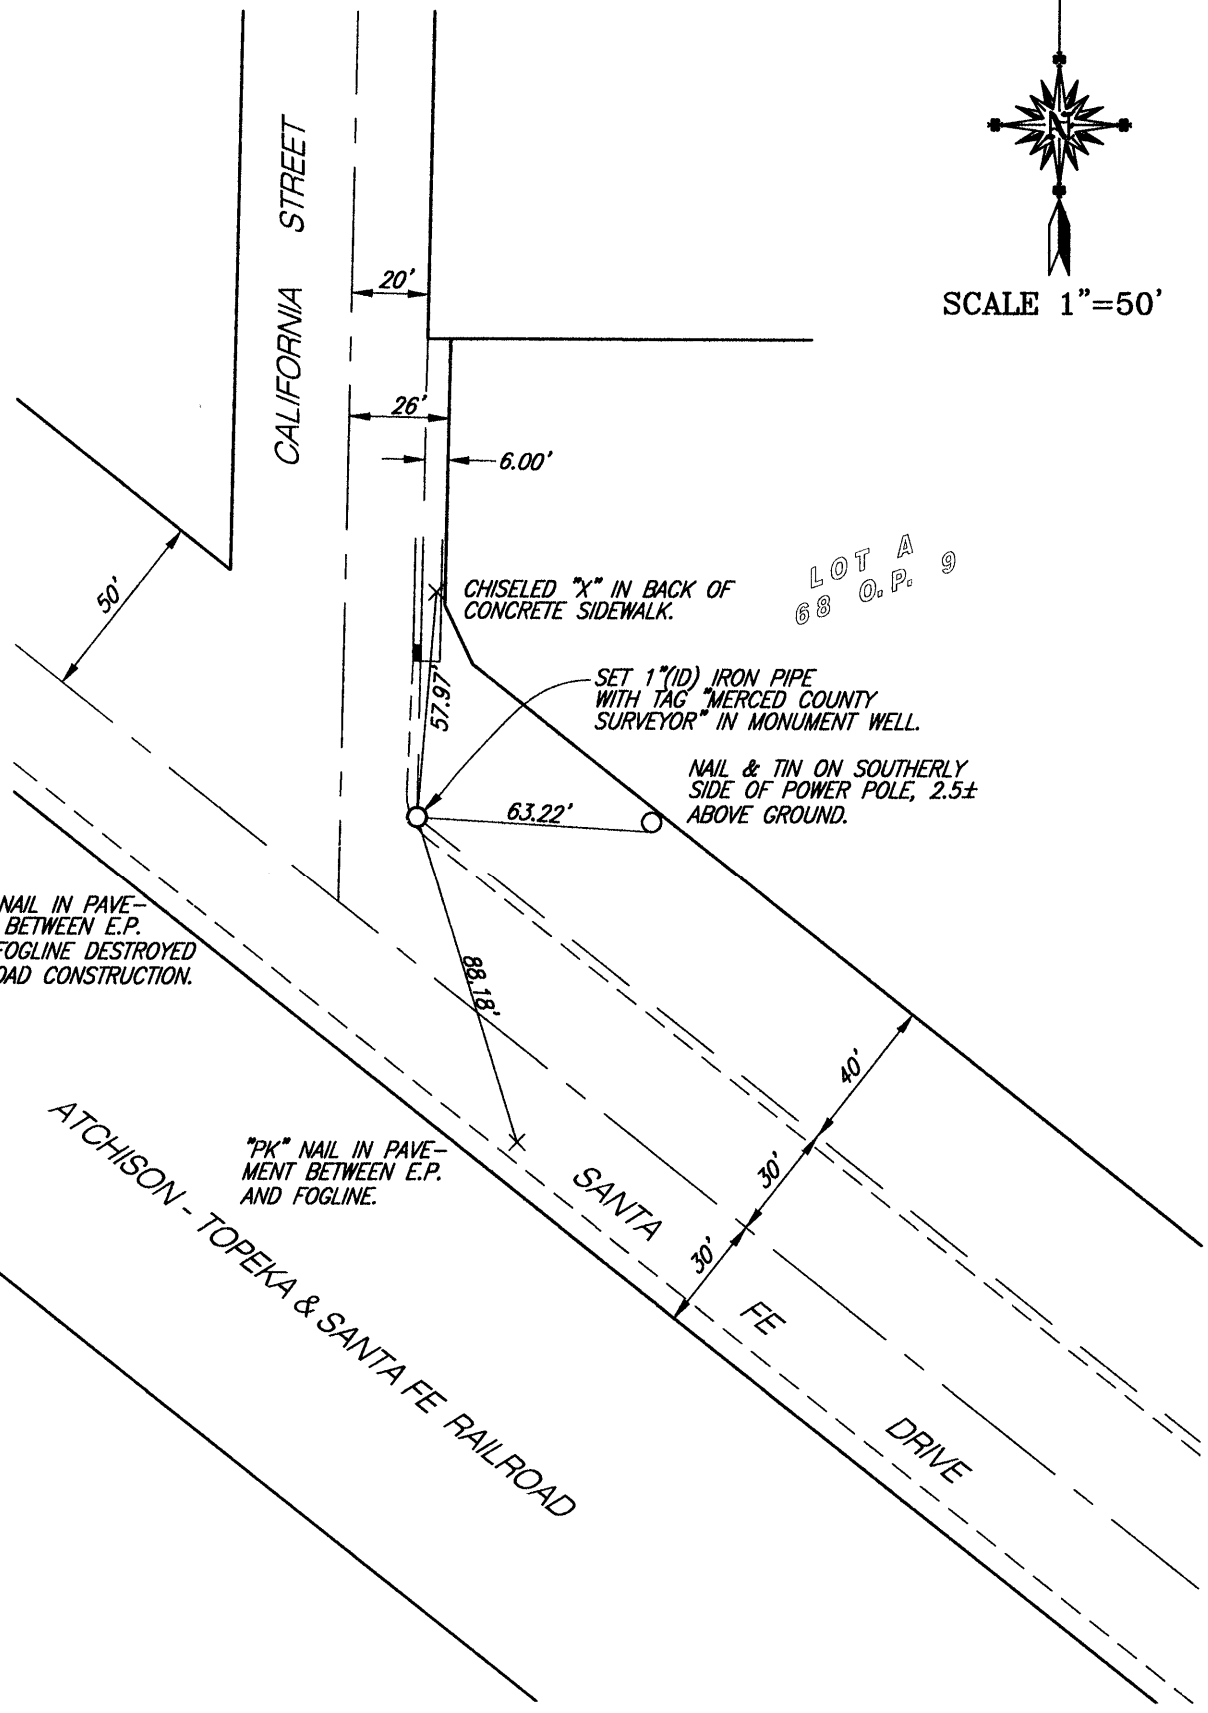
CHISELED "X" IN BACK OF  
CONCRETE SIDEWALK.

SET 1"(ID) IRON PIPE  
WITH TAG "MERCED COUNTY  
SURVEYOR" IN MONUMENT WELL.

NAIL & TIN ON SOUTHERLY  
SIDE OF POWER POLE, 2.5±  
ABOVE GROUND.

"PK" NAIL IN PAVE-  
MENT BETWEEN E.P.  
AND FOGLINE DESTROYED  
BY ROAD CONSTRUCTION.

"PK" NAIL IN PAVE-  
MENT BETWEEN E.P.  
AND FOGLINE.
