CORNER RECORD

COUNTY OF Merced T. 10 S. R. 9 E. M.D.B. & MERIDIAN CALIFORNIA

CORNER IDENTIFICATION — DATE OF VISIT June 19, 1986

Northwest corner of Section 6, 10/9

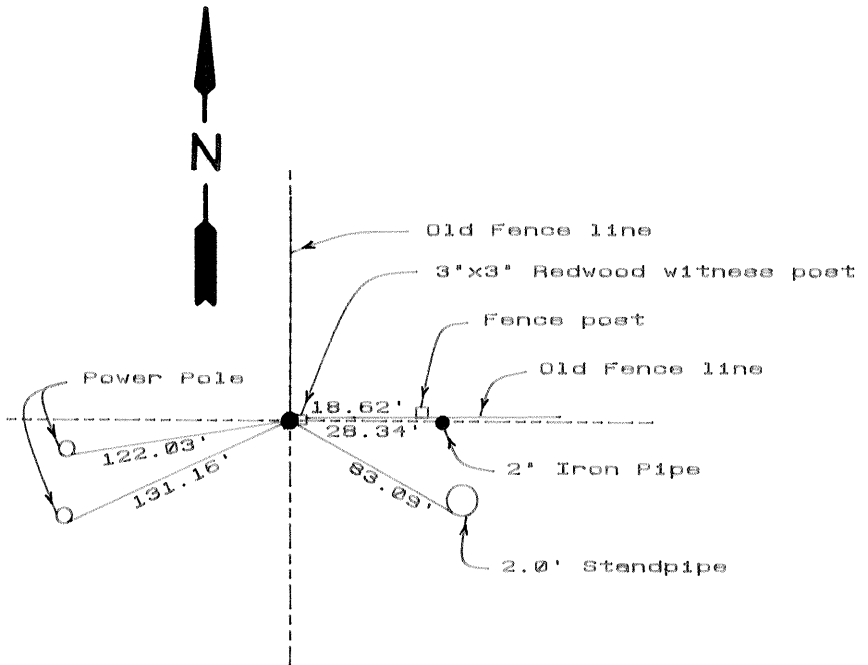
Ties

Found a badly decayed 3" x 3" redwood, Down 1.3'

- 0.70' West of 3" x 3" redwood witness post painted white, 0.5' below ground.
- 122.03' East of nail and shiner in power pole with transformers.
- 131.16' Northeast of nail and shiner in power pole with switch boxes.
- 83.09' West of (x) on 2' diameter concrete standpipe.
- 18.62' West of nail and shiner in fence post.
- 28.34' West of 2" iron pipe with tag L.S. 4714.

Set a 1" O.D. x 28" galvanized iron pipe with plastic plug L.S. 5355 in center of 3" x 3" redwood, 1.3' below surface.
