**CORNER RECORD**

Document Number 3050-B  
County of MERCED, California

Brief Legal Description CENTERLINE MONUMENT INDIANA AVE 1950'± S. OF DENTON LEAK ROAD. T.10S, R.13E SEC. 30

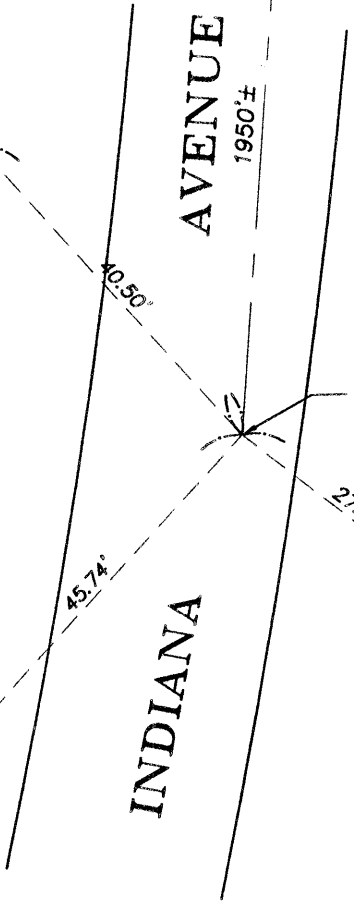
A description of the physical condition of the monument as found and as set or reset: FOUND 3/8" BAR IN MONUMENT WELL W/ COUNTY SURVEYOR'S TAG. MAY BE DESTROYED DURING CONSTRUCTION

SET NAIL & TIN  
IN ELECTRICAL  
SERVICE POLE

FOUND 5/8" IRON BAR  
IN MONUMENT WELL

SET 1/2" BAR
