CORNER RECORD

Document Number 357

Brief Legal Description Southwest Corner Section 18, T. 8 S. R. 9 E., M. D. B. & M.

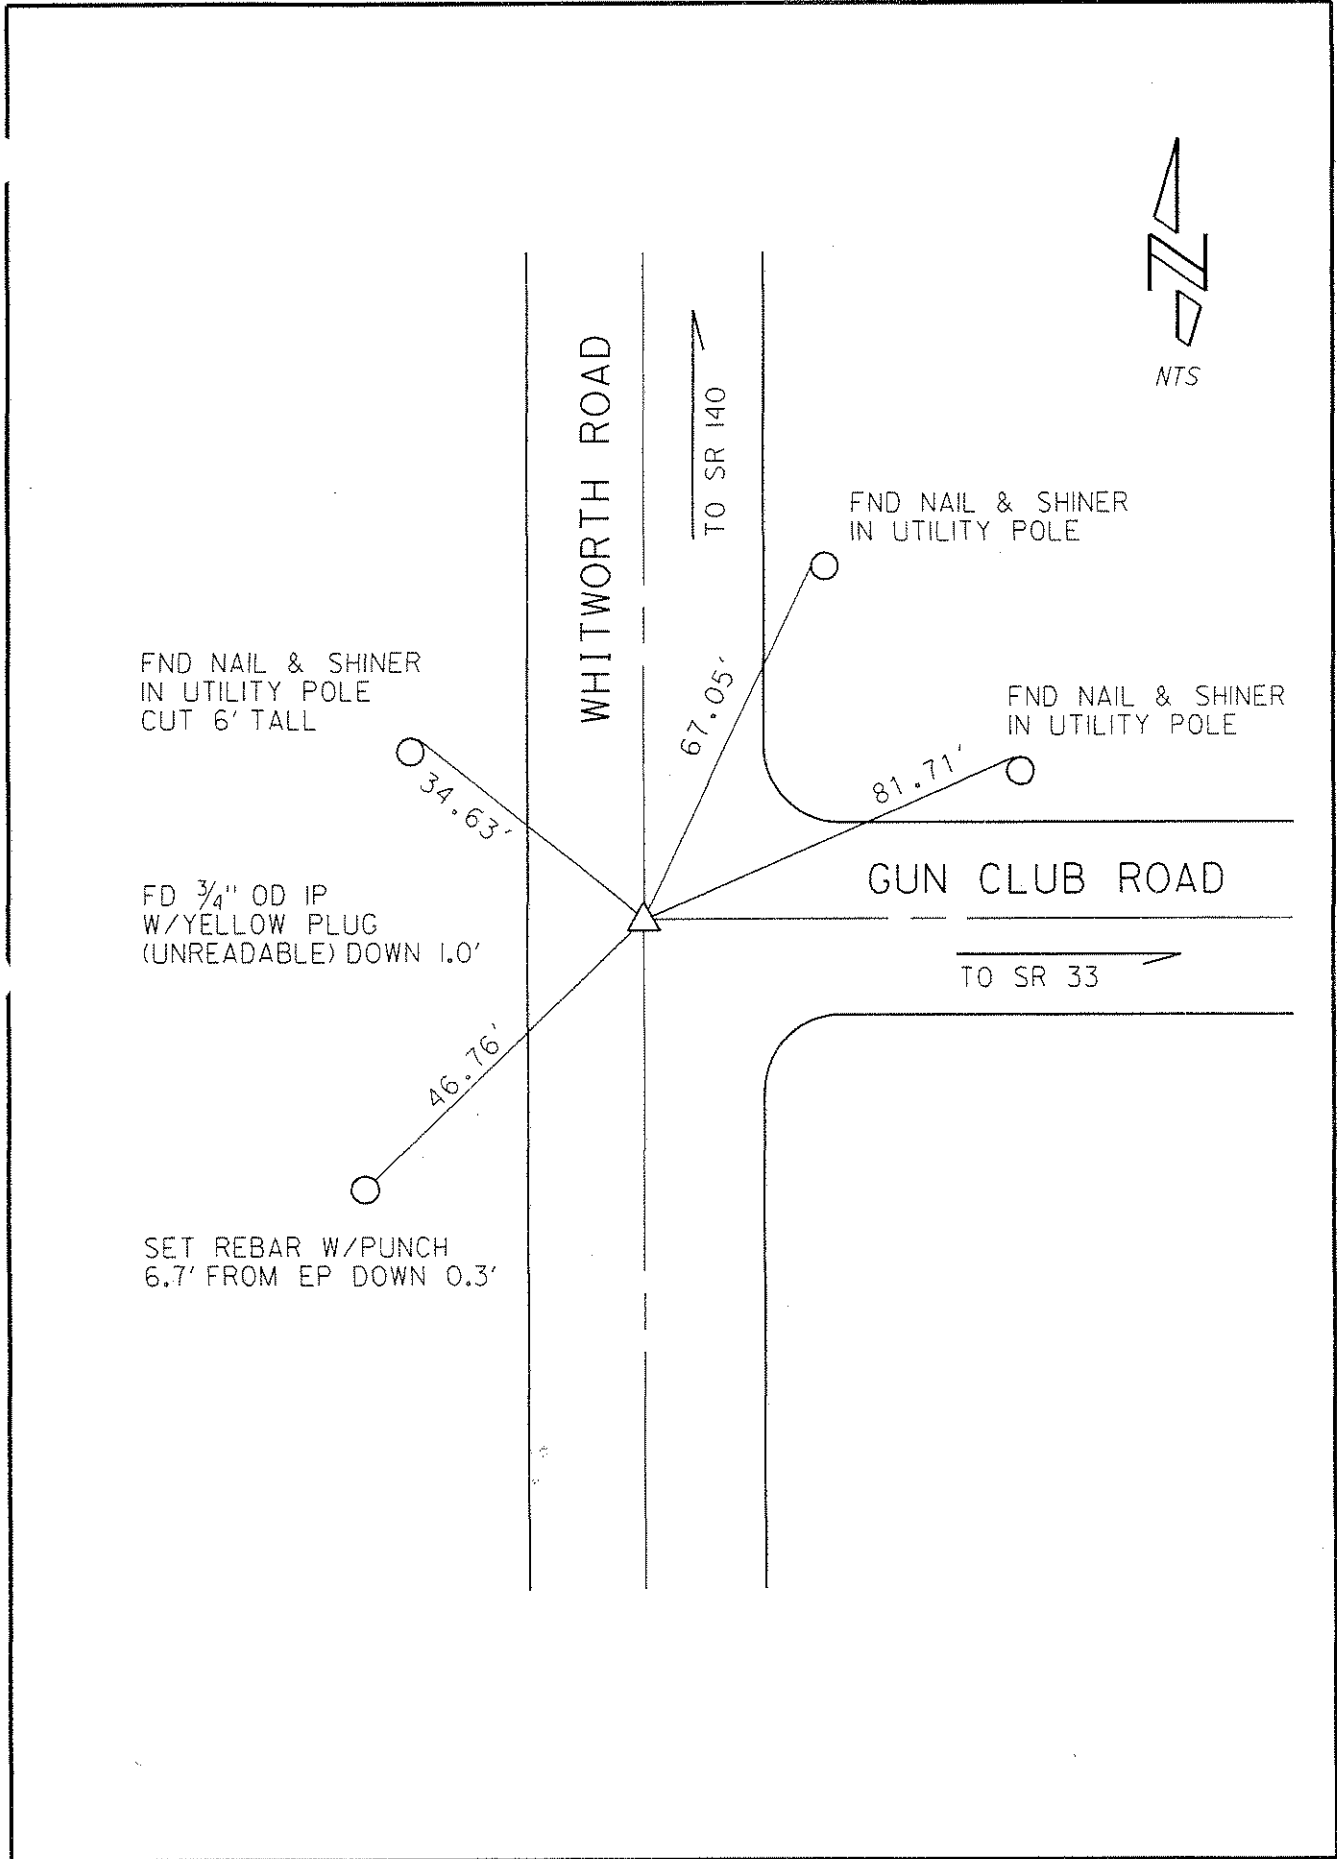
Identification and type of corner found: Evidence used to identify or procedure used to establish or reestablish the corner:
Found 3/4" OD IP w/YPP "unreadable" down 1.0'. Inside 2" IP per
Parcel Map vol. 104, pg. 17, & Record of Survey vol. 51, pg. 36.

A description of the physical condition of the monument as found and as set or reset: Monument was found in
good condition.

FND NAIL & SHINER
IN UTILITY POLE

FND NAIL & SHINER
IN UTILITY POLE
CUT 6' TALL

81.71'

34.63'

FD 3/4" OD IP
W/YELLOW PLUG
(UNREADABLE) DOWN 1.0'

46.76'

SET REBAR W/PUNCH
6.7' FROM EP DOWN 0.3'
