CORNER RECORD

Document Number 365 D

Brief Legal Description S.W. Corner Section 20, T. 8 S., R. 9 E. Mount Diablo Meridian

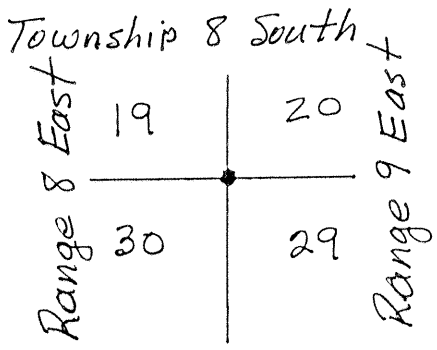
Old Redwood post - see sketch other side

Found 2" chiseled

Made dimple in center
 87°19'54"
 46.15'

Wing Wall
 NE Abutment
 Bridge over Gargas
 Creek

Found Jan. 09, 2001
 -0.5' below surface
 Township 8 South

7" Rail post support
 Plate South end
 5" Bridge-check Str.
 center punched
 this bolt.

7" wide x 8' long head wall slide gate
 T.O. 1 1/2" up 9 1/2" about center of
 slide gate stem

large bolt spike 0.3' in
 but ant. 1 1/2' in
