CORNER RECORD

COUNTY OF MERCED T. 5S. R. 12E M.D. MERIDIAN CALIFORNIA

Northwest corner of section 14

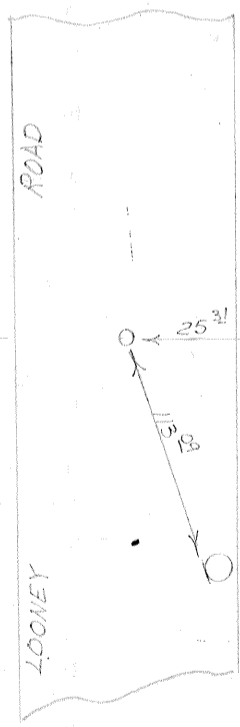
SKETCH: (Include reference tie or witness points, remarks and topo of area)

Monument found was brass cap with "7" stamped in it. Found November 8, 1976. Found witness posts 19.85 feet west, 20 feet east and 25 feet east. Reestablished by using swing ties in field book 711 page 23.

NOTE: WITNESS MONUMENTS USED TO IDENTIFY SECTION CORNER ARE OBLITERATED.

SECTION CORNER IS 26 FEET SOUTH OF ALMOND ORCHARD TO WEST AND 19 FEET WEST OF POLE LINE TO SOUTH.

1/4" O.D.I.P. placed 5" IN center of rotted 3"x4" R.W. post tagged "MERCED COUNTY SURVEYOR"

Brass cap was destroyed during road construction. Replaced with 1/4" outside diameter iron pipe, 30" long. Tagged "Merced County Surveyor"
