CORNER RECORD

Document Number 828-X

County of Merced, California

Brief Legal Description GPS Control Point

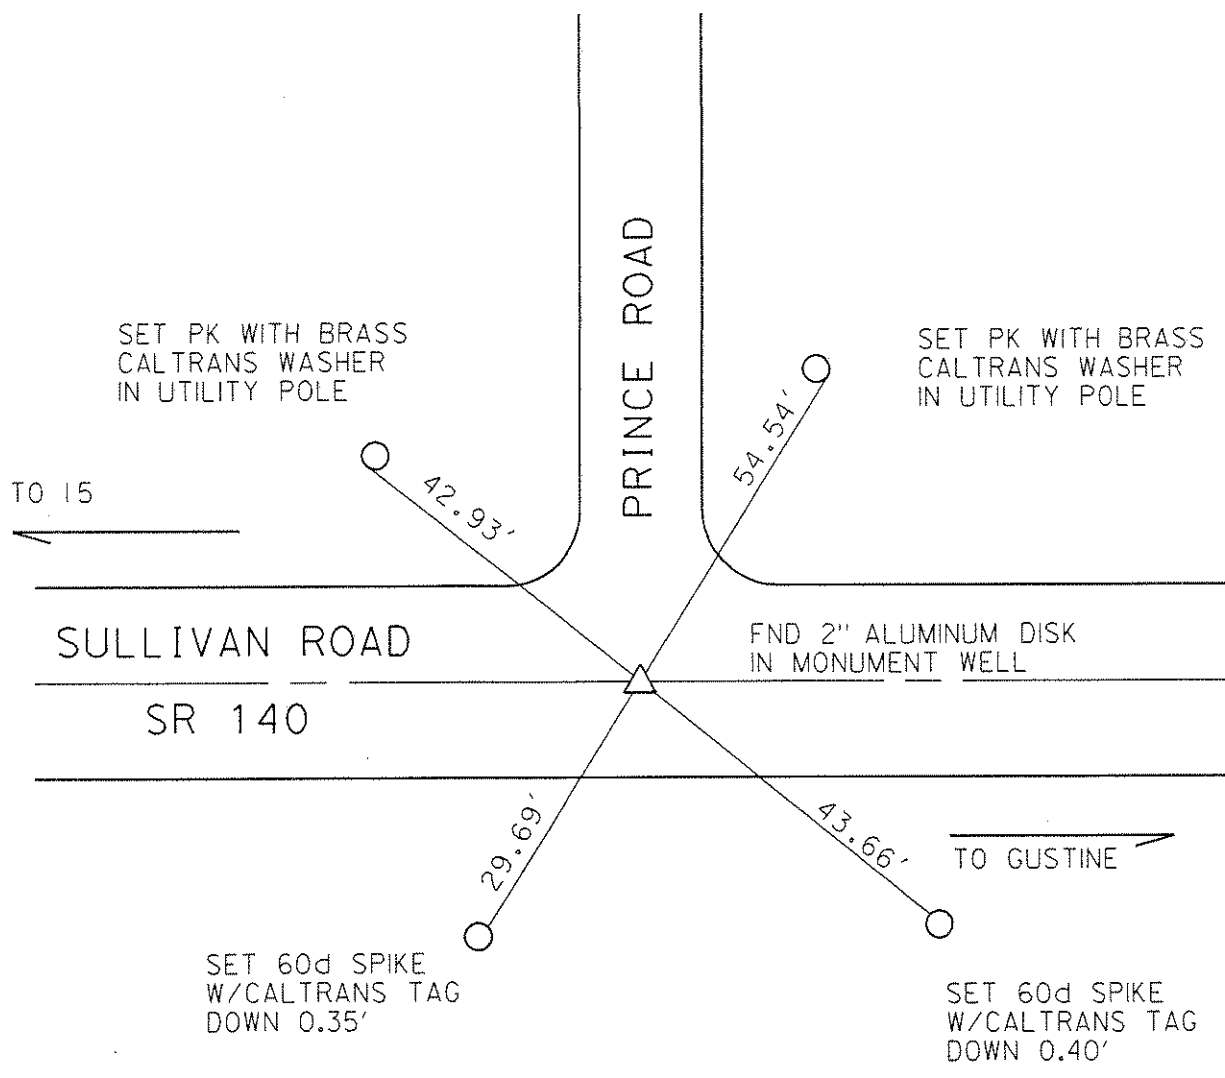
NTS

Identification and type of corner found: Evidence used to identify or procedure used to establish or reestablish the corner:
Found 2" aluminum disk atop rebar on centerline of SR 140/Sullivan Road at Prince Road down 0.4' as per RS Volume 28 Pages 15-16, and Subdivision Map Volume 44 Page 49, Sheet 2 of 4, in 1' diameter well.

A description of the physical condition of the monument as found and as set or reset: Monument was found in good condition. Information on disk reads "GPS/GIS 2005 RCE (mashed)".
