# CORNER RECORD

Brief Legal Description NE. COR SECT 18, T9SR9E, MDBEM

#880

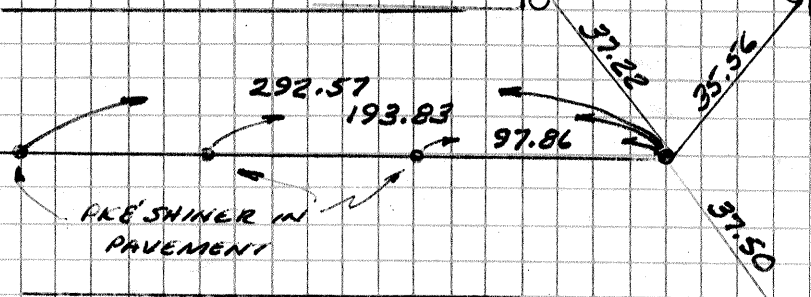
Identification and type of corner found: Evidence used to identify or procedure used to establish or reestablish the corner: 3/4" I. PIPE WITH PLASTIC PLUG & NAIL AT SURFACE, MATCHES COUNTY TIES AND IS IN CENTER OF INTERSECTION.

A description of the physical condition of the monument as found and as set or reset: MONUMENT APPEARS TO BE IN GOOD CONDITION

7  
18  
FO. NAIL &  
200 RPS AT  
SW COR SECT 7 1/9

FOUND 3/4" I. PIPE  
WITH PLASTIC PLUG  
& NAIL AT SURFACE
