CORNER RECORD

Document Number 1351-L(2)

County of Merced, California

Brief Legal Description centerline Monument for Beginning of Curve on Olive Avenue

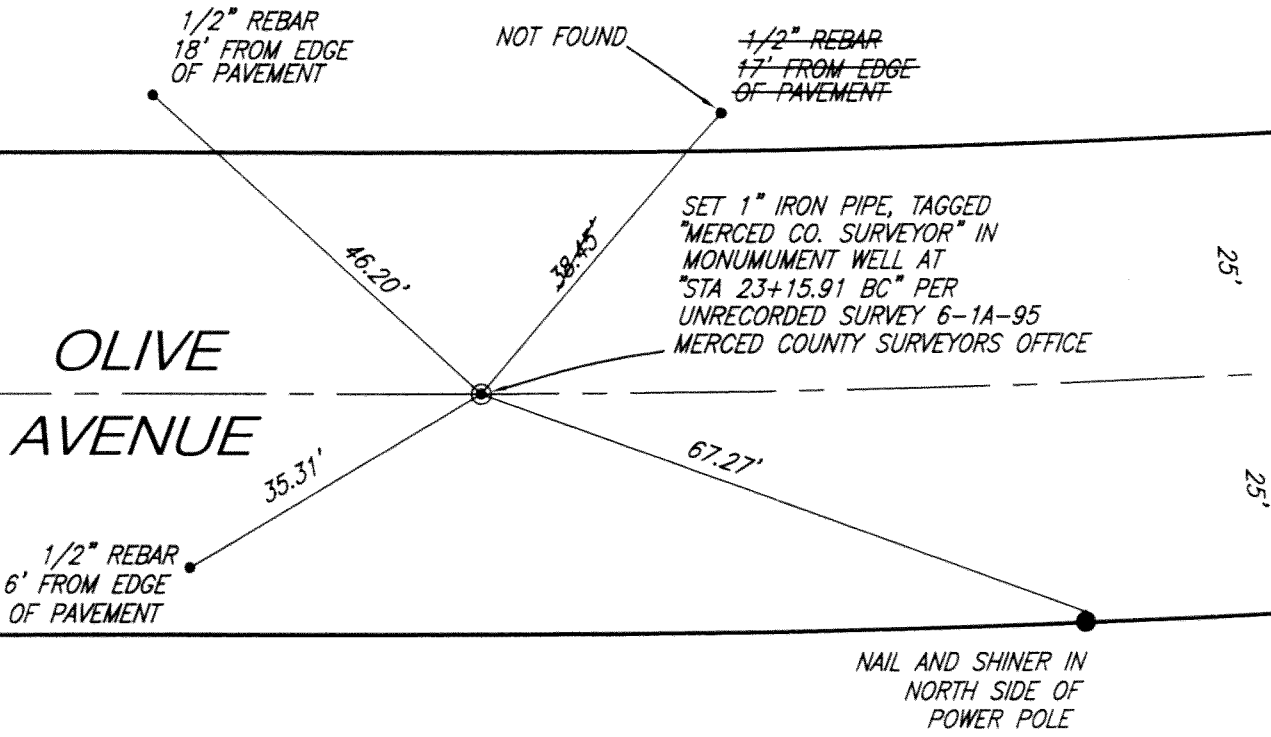
SCALE: 1" = 20'

Monument destroyed by road reconstruction. Set 1" iron pipe tagged "Merced Co. Surveyor" in monument well using ties set on Corner Record 1351-L dated October 3, 2012 at "STA 23 + 15.91 BC" per unrecorded survey 6-1A-95.
