CORNER RECORD

Document Number 1351-M
County of Merced, California

City of _____
Brief Legal Description Centerline Monument for End of Curve on Olive Avenue

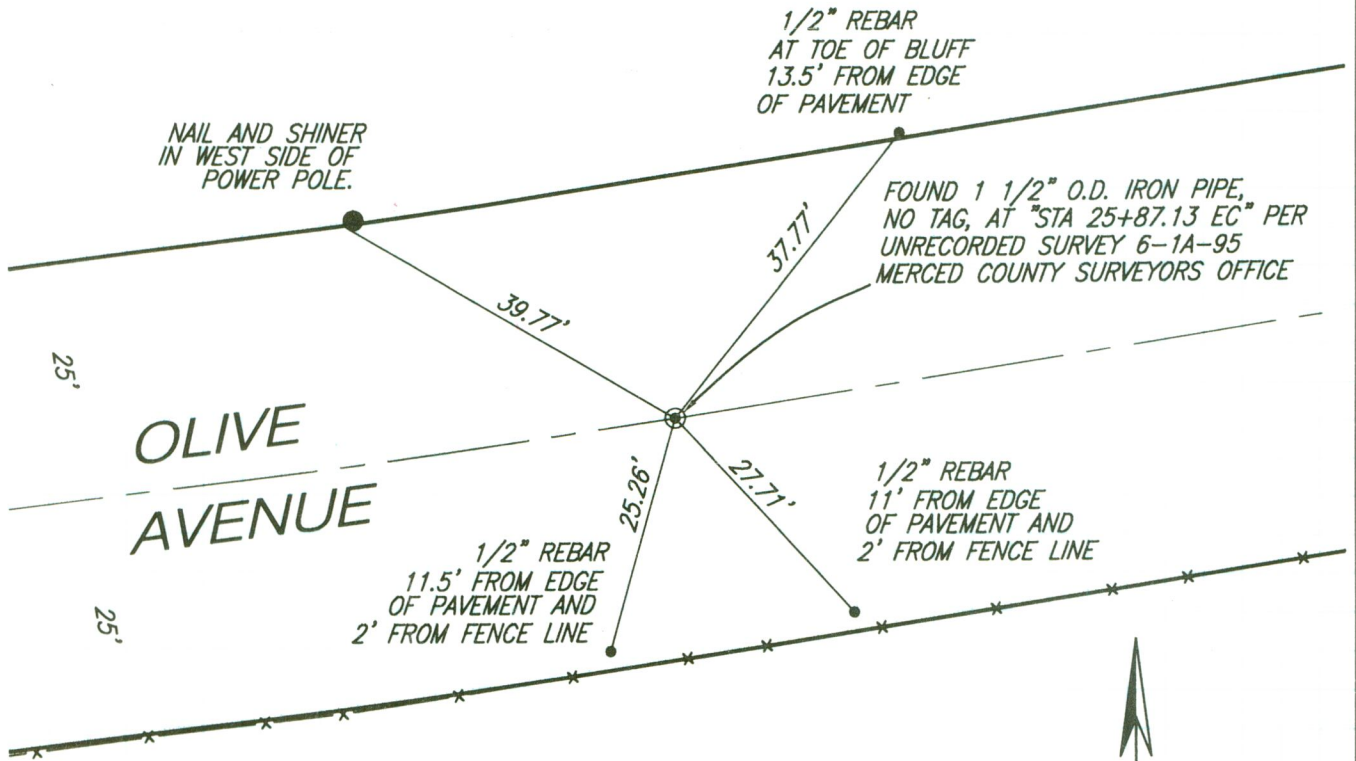
FOUND 1 1/2" O.D. IRON PIPE,
NO TAG, AT "STA 25+87.13 EC" PER
UNRECORDED SURVEY 6-1A-95
MERCED COUNTY SURVEYORS OFFICE

1/2" REBAR
11.5' FROM EDGE
OF PAVEMENT AND
2' FROM FENCE LINE

1/2" REBAR
11' FROM EDGE
OF PAVEMENT AND
2' FROM FENCE LINE
