CORNER RECORD

Document Number 1351-0 (2)

Brief Legal Description Centerline Monument for End of Curve on Olive Avenue

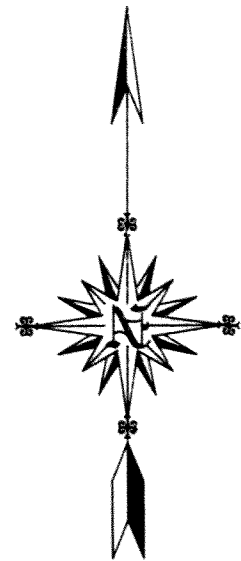
1/2" REBAR
AT TOE OF BLUFF
17' FROM EDGE
OF PAVEMENT

SET 1" IRON PIPE, TAGGED
"MERCED CO. SURVEYOR" IN
MONUMENT WELL AT
"STA 32+18.14 EC" PER
UNRECORDED SURVEY 6-1A-95
MERCED COUNTY SURVEYORS OFFICE

OLIVE
AVENUE

1/2" REBAR
1' FROM FENCE

NAIL AND SHINER IN
AT NORTHEAST CORNER
OF FENCE POST

Monument destroyed by road reconstruction. Set 1" iron pipe, tagged "Merced Co. Surveyor" in monument well using ties set on Corner Record 1351-D dated October 3, 2012 at "STA 32+18.14 EC" per unrecorded survey 6-14-95.
