CL. RECORD

COUNTY OF Merced T. 10S R. 14E M.D.B. & M. MERIDIAN CALIFORNIA
CORNER TYPE: GOV'T. CORNER MEANDER RANCHO CONTROL OTHER
CORNER IDENTIFICATION — DATE OF VISIT January 19 78

Northwest corner

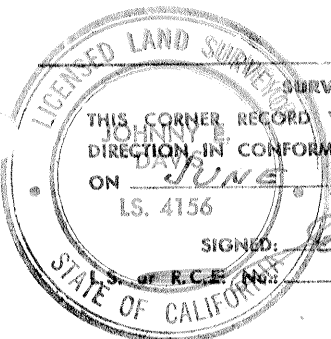
SKETCH: (Include reference tie or witness points, remarks and topo of area)

Found and tagged L.S. 4156, a 5/8" steel rebar @ 0.1 feet below road surface

- 30.00 ft. South of intersection of Orchard Way and Jefferson Road
- 26.53 ft. Southwest of nail & shiner in 4" x 6" post
- 72.63 ft. Southwest of nail & shiner in power pole
- 67.20 ft. Southwest of 2" O.D. pipe in fence corner
