CORNER RECORD

Document Number 3666

City of \_\_\_\_\_ County of Merced, California

Brief Legal Description E. 1/4 Corner, Sec. 2, T. 7 S, R. 10 E., M. D. B. & M.

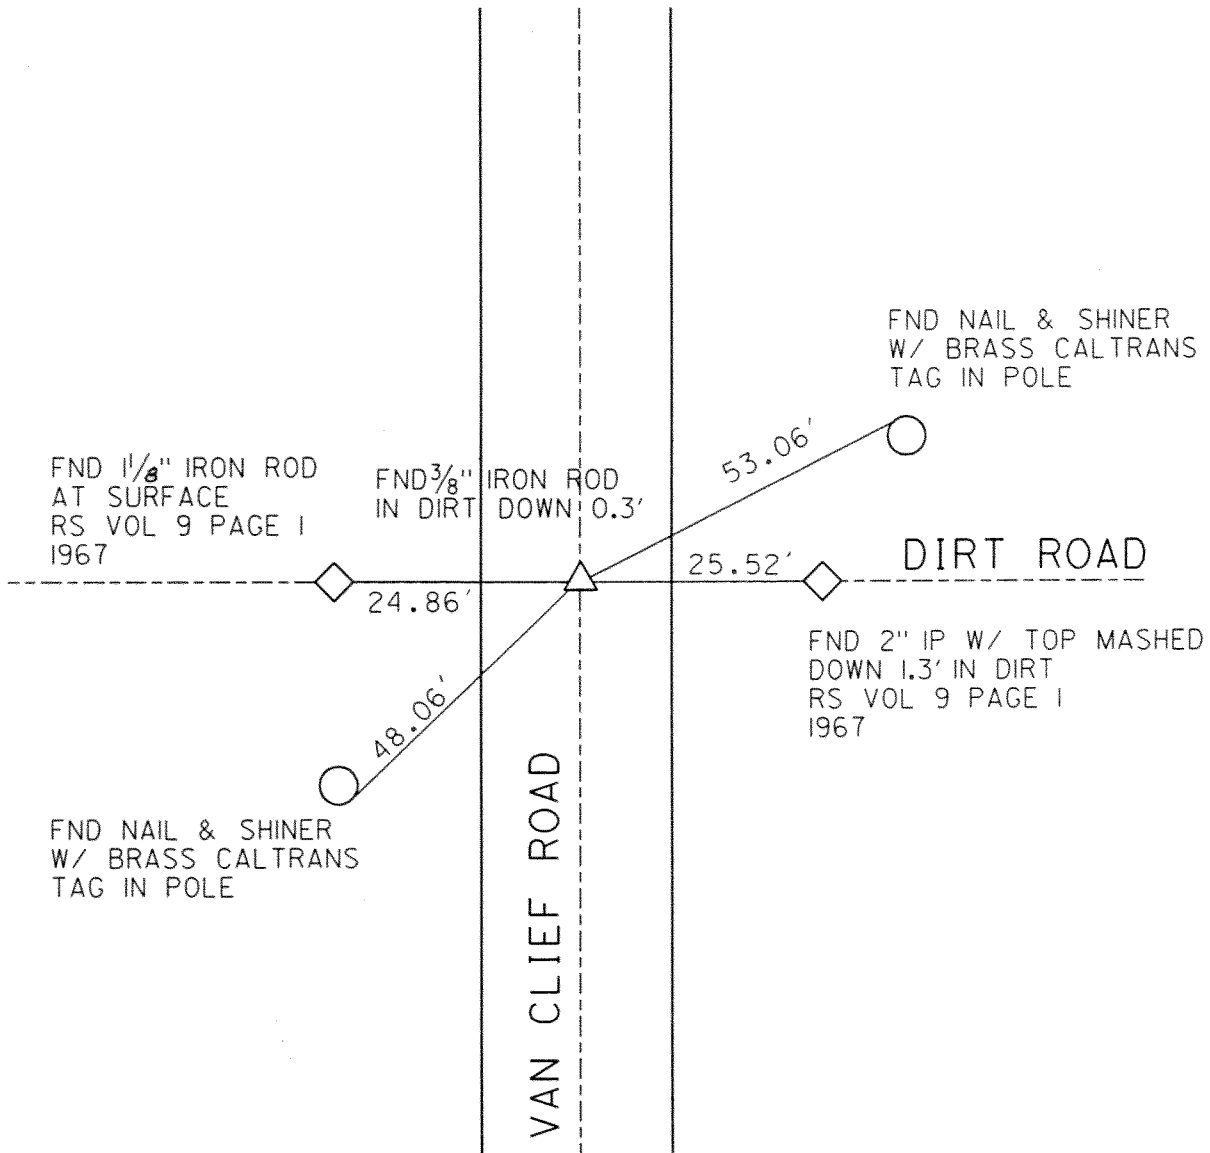
NTS

Identification and type of corner found: Evidence used to identify or procedure used to establish or reestablish the corner:  
Found 3/8" iron rod 0.3' down in dirt below asphalt surface of Van Clief Rd. per R.S. vol. 9 page 1, 1967. The following reference monuments were found; a 1 1/8" steel shaft West of the monument and a 2" Iron Pipe East of monument per R.S. vol.9 page 1, 1967.

A description of the physical condition of the monument as found and as set or reset: Monument was found in good condition. Top was corroding. Reference monuments found in good condition except that the 2" Iron pipe has a slightly mashed top.
