CORNER RECORD

Document Number 3747

Brief Legal Description NE Corner of Sec. 26 T.9S., R.10E. M.D.M.&B.

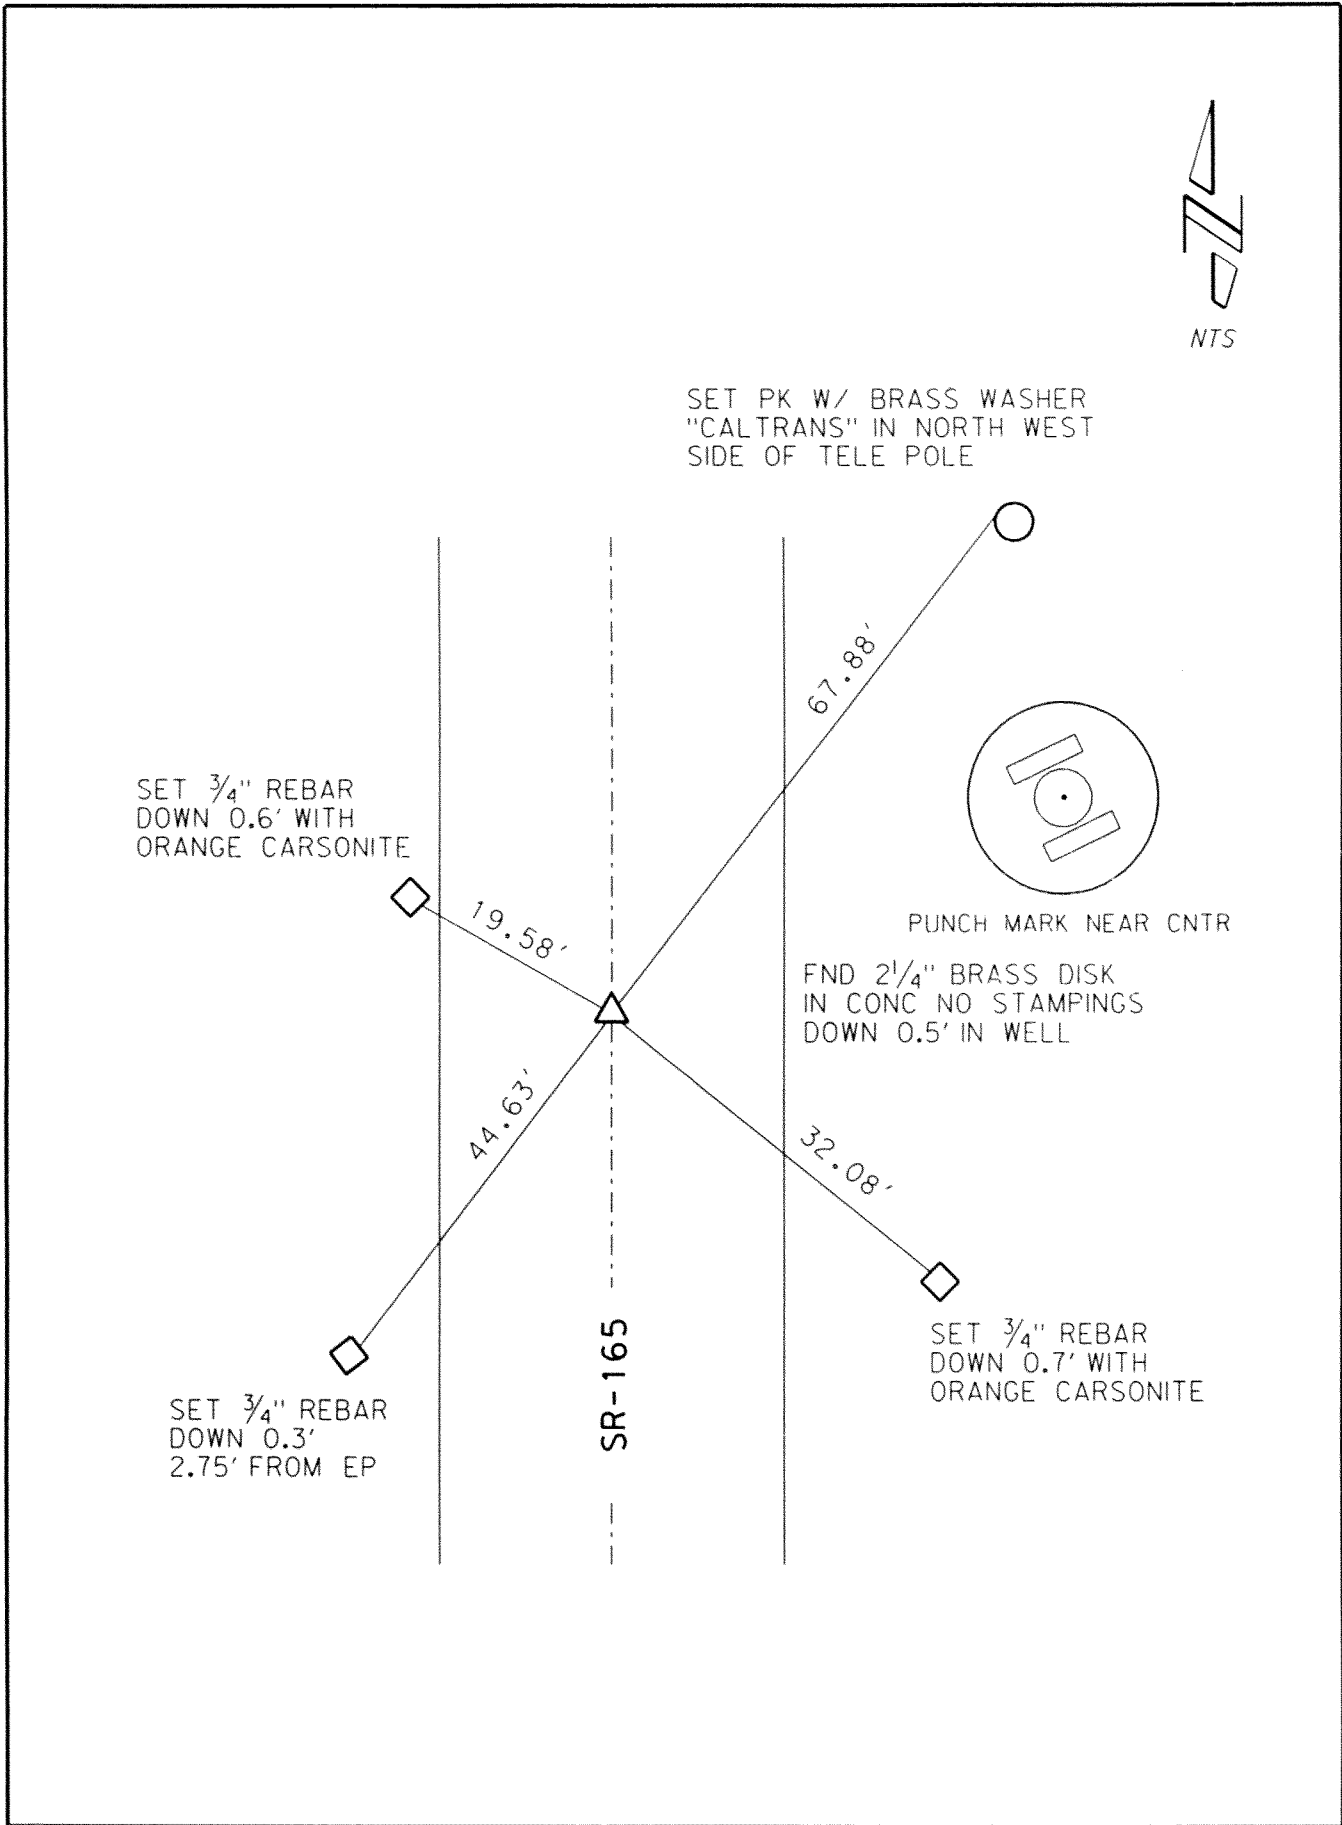
SET PK W/ BRASS WASHER
"CALTRANS" IN NORTH WEST
SIDE OF TELE POLE

SET 3/4" REBAR
DOWN 0.6' WITH
ORANGE CARSONITE

PUNCH MARK NEAR CNTR

FND 2 1/4" BRASS DISK
IN CONC NO STAMPINGS
DOWN 0.5' IN WELL

SET 3/4" REBAR
DOWN 0.3'
2.75' FROM EP

SET 3/4" REBAR
DOWN 0.7' WITH
ORANGE CARSONITE
